# Subcutaneous Tethering of Ventriculoperitoneal Shunt Catheter Due to Calcification- A Late Complication of VP Shunt Surgery

**Keywords:** VP Shunt surgery late complication; Shunt catheter tethering; Calcification

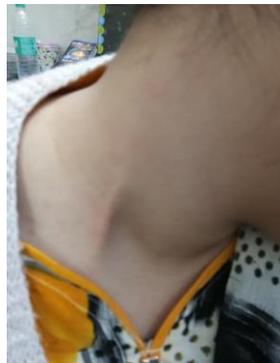
**FIG. 1. Tighting due to tethering of shunt tube in neck and showing redness due inflammation and calcification around tube.**

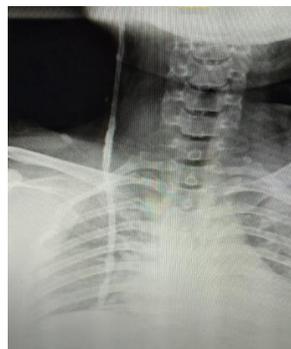
**FIG. 2. X-rays neck and chest showing deposition of calcium and minerals around shunt tube.**

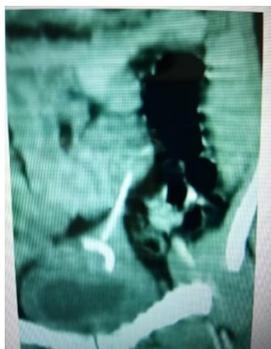
**FIG. 4. CT Scan abdomen showing migration of distel end in to urinary bladder wall.**
